# Hardening and Testing the Video Transmitter and Camera for the Shoulder-Fired Video Imager

ARL-TR-3353 November 2004

Michael L. Nair Weapons and Materials Research Directorate, ARL

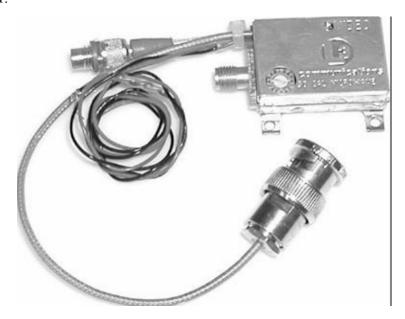
Figure 1. VNTX transmitter.

The transmitter selected for the imager is the VNTX series, shown in figure 1, manufactured by Southern California Microwave for use in law enforcement. This transmitter is used by Aerovironment<sup>4</sup> in ARL's SOAR unmanned aerial vehicle (UAV). The transmitter was built to the specifications given by Aerovironment for the SOAR UAV. See table 1 for the specifications of the transmitter.

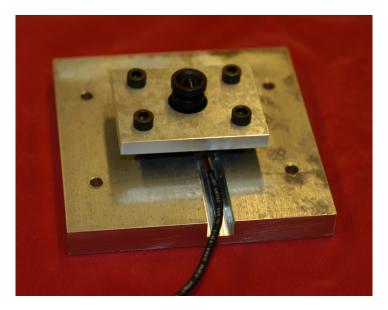
Figure 5. Camera mounted in shock fixture.

The top piece is a plate with a clearance hole for the lens and four holes for mounting the top piece to the bottom plate. The two parts were held together with four 10-32 cap screws, as shown in figure 5.

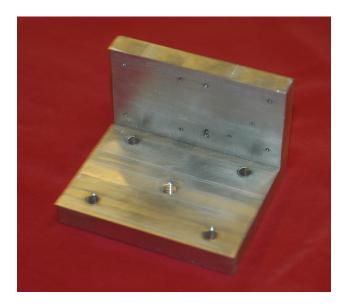
Figure 6. Transmitter shock mount.

The second fixture, shown in figure 6, is an L-shaped piece used for shock testing the transmitter. Two separate hole patterns permit mounting the transmitter so that the long axis of the transmitter is either horizontal or vertical. The transmitter is mounted to the fixture with four 2-56 machine screws. The bottom side of the fixture has a 10-24 threaded hole for the accelerometer as well as

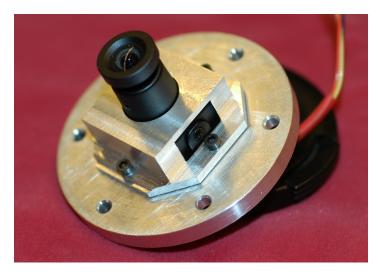
Figure 7. The PC182XS camera mounted in the camera mounting plate and mounting box.

During the evaluation of the transmitter and camera, four of the imager round bodies were manufactured at the ARL machine shop. Five camera mounting plates and five camera mounting boxes designed for the PC182XS camera were completed at approximately the same time. After completion of these parts, they were used to test the camera while installed in the imager round. When mounted in the round, the camera is held by clamps between the camera mounting plate and the mounting box, much like it is in the shock fixture. The clamping force is

applied to the camera immediately around the protrusion for the lens. The PC182XS camera mounted to the camera mounting plate and mounting box are shown in figure 7.

The top piece of the camera shock fixture was analyzed and ALGOR predicted a displacement of 9.9 x 10<sup>-7</sup>m. The difference in displacement is apparently the cause for the camera failure. While the deflection of the camera mounting plate and mounting box is small, a component of the acceleration present in these parts, which was not present in the more rigid shock fixture, likely caused a failure of one or more of the camera components.

After we decided to use the PC72XS camera, the camera mounting plate and mounting box were redesigned to accommodate the geometrical differences in cameras. Instead of having a clearance hole in the mounting box, a pocket was milled through the mounting box to secure the camera around the exterior of the small step exterior to the lens protrusion. Only two sets of the revised parts were produced because two of the rounds are mass simulators and do not require functioning cameras. Figure 8 shows the solid model of the round with the PC72XS camera, revised camera mounting plate, and mounting box installed.

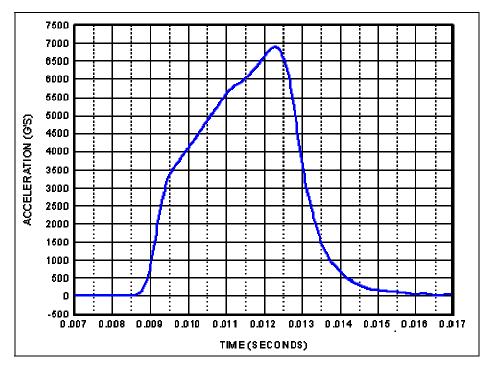
Figure 9. BDM nominal acceleration.

The acceleration data for the BDM were provided by their manufacturer, Talley Defense Systems. Figure 9 shows the time history of the acceleration of the standard BDM.

Since the imager warhead is heavier than the standard BDM warhead, the peak acceleration experienced by the components should be lower than the 6800 g's shown in figure 9. With the basic formula for force

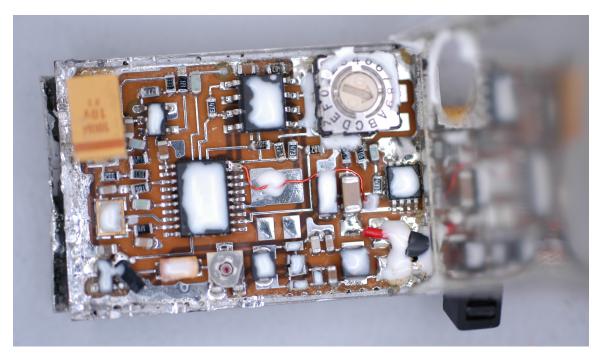
Figure 10. Southern California Microwave VNTX transmitter.

was functional, it was again taken to Aerovironment's facility where it was successfully tested with the GCU. The test showed that the transmitter survived the expected launch acceleration without failure. The second transmitter was filled with glass beads according to the same process just described; however, it malfunctioned after the glass beads were inserted and the case was soldered. Testing showed that the center frequency was now at approximately 1550 MHz. After the transmitter case was opened (see figure 10), no obvious causes of the problem were seen and the unit was returned to Southern California Microwave for investigation. Southern California Microwave reported that several components were disconnected from the circuit board, which was likely caused by the heat from the case being un-soldered. Southern California Microwave repaired the unit and returned it with the transmitter case open, which allowed for easy filling of the case with the glass beads. After we re-soldered the case, the unit was retested on the spectrum analyzer and the center frequency was measured at 1787 MHz.

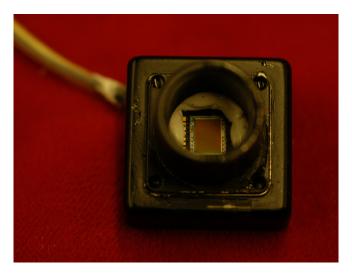
mixed with LV23 catalyst in a 100:25.4 ratio. The encapsulated camera is shown in figure 11 without the lens assembly; note the bead of sealant around the CCD.

Figure 11. Encapsulated camera showing the RTV sealant around the CCD.

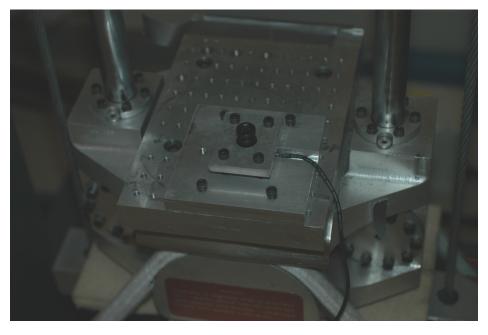
Figure 12. Camera fixture mounted to MTS shock table.

The camera was mounted to the shock table in its shock fixture, shown in figure 12, and shock tested to a peak acceleration of 8085 g's, as measured by an accelerometer mounted to the fixture. The video output of the camera was observed on a black-and-white monitor during the shock event. The camera survived the shock event, as noted by the clear video image on the monitor after the test.

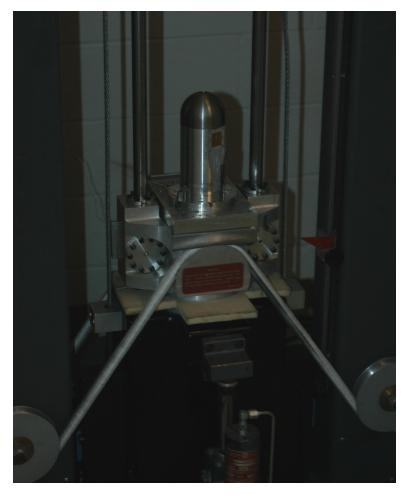
Figure 13. Imager round mounted to shock table.

After both the transmitter and camera successfully passed the survivability tests, the components were installed in the imager round and the round was mounted to the shock table, as seen in figure 13. The transmitter signal was received by a GCU which includes a small screen displaying the video signal.

The imager round was subjected to a shock test in which the peak acceleration was measured at 7532 g's. During the shock event, the video stopped and the video output of the GCU turned black. The GCU controller showed some type of white streaks but no intelligible images. The imager round was disassembled to determine the cause of failure. We removed the camera from the round and tested it by connecting it to a 12-volt power supply and a small black-and-white monitor. Testing of the individual components revealed that the camera was no longer functional and had failed during the shock test. To ensure that the transmitter was not damaged, a new camera was connected to the transmitter and a normal video signal was received by the GCU. To ensure that the camera failure was not an anomaly, another test of the imager at a similar shock level was conducted; the recorded shock is shown in figure 14. This camera was also slightly modified in that the connector for the video and power leads was removed and leads

were soldered directly to the through-holes on the circuit board before encapsulation. Again, the camera failed in exactly the same way; replacement of the camera indicated that the transmitter was undamaged.

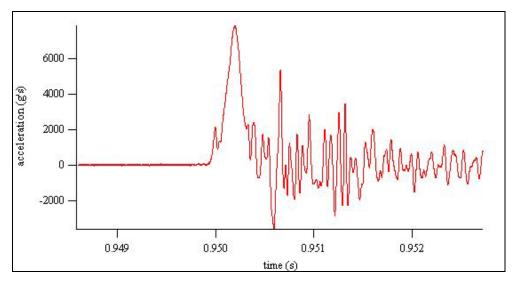
Figure 14. Recorded shock pulse during test of video imager.

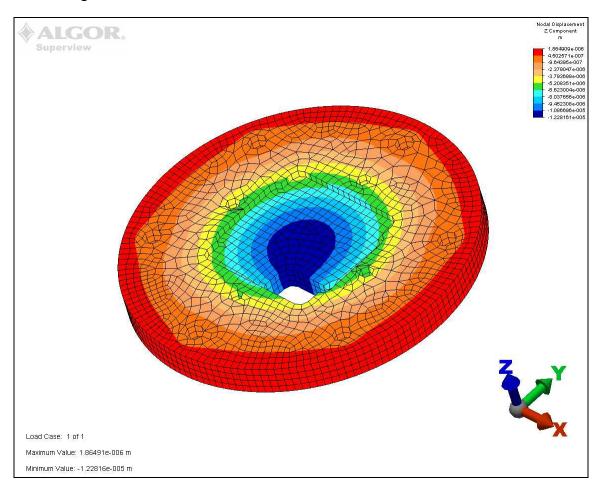
In an attempt to determine the cause of failure, FEA was performed on both the camera mounting plate and the camera mounting box with ALGOR<sup>12</sup>. A static analysis was conducted on the camera mounting plate. The plate was constrained from movement in the axial direction of the round by the screw holes. A force of 525 newtons was applied to the pocket where the camera sits. The analysis, shown in figure 15, predicts that the maximum deflection of the plate in the axial direction occurs at the center of the pocket and is equal to 1.228 x 10<sup>-5</sup>m.

Figure 15. Displacement graph of the camera mounting plate from FEA.

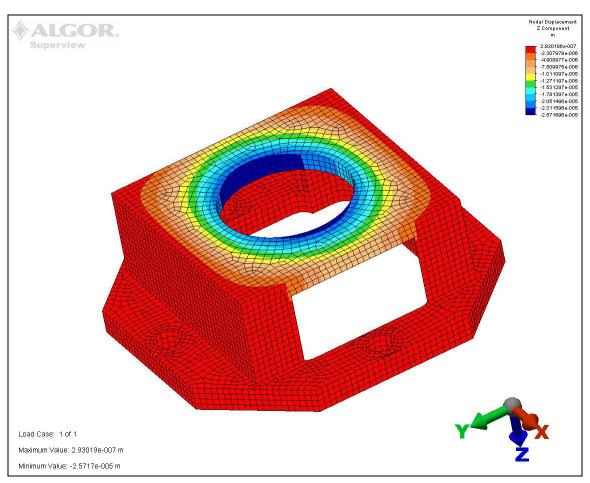
Several different analyses of the mounting box were conducted. To simplify the calculations, a static analysis was used. The force applied to the piece is equal to 1/3 the launch acceleration multiplied by the mass of the camera. This analysis assumes that the force applied to the mounting box will be at a maximum as the round leaves the barrel. This acceleration can be assumed to be approximately an order of magnitude less than the launch acceleration (Barrett, 2004). To ensure that sufficient loading is applied, the set-forward acceleration is assumed to be 1/3 the launch acceleration. The analysis indicates that a deflection of 2.57 x 10<sup>-5</sup>m is possible,

given the specified acceleration. A graph showing the displacements in the axial direction is presented in figure 16.

Figure 16. Displacement graph of the mounting box from FEA.

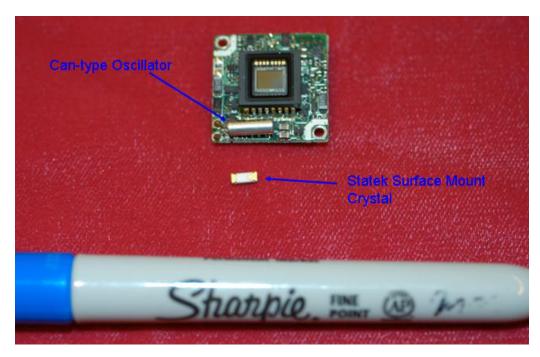
The author was then referred to an ARL report (Condon et al., 2001), which detailed a similar problem that was encountered during the shock testing of a Polaris Industries camera. To harden the camera for gun launch, the authors replaced a can-type crystal oscillator with a surface mount crystal before encapsulating the camera. This change allowed the camera to survive much higher accelerations than possible with the original component. Originally, the intention was to procure surface mount crystals for the PC182XS camera and try the same approach to harden the cameras. Dove Electronics was contacted about the possibility of acquiring new crystals but the clock frequency of 28.563 Mhz for the camera is a non-standard frequency. In order to acquire crystals

Figure 17. PC72XS camera circuit board with Statek crystal.

at that frequency, approximately four months would be required for development and testing. To avoid the delay, a faster path was chosen. During further work by one of the authors of ARL-MR-510 (John Condon of ARL), it was discovered that a second camera, the Supercircuits PC72, uses the same clock frequency as the Polaris Industries camera. The PC72 camera is slightly larger than the PC182 but shares a similar form factor. To determine if the PC72 camera would meet the requirements for the concept, several copies of the PC72XS camera were obtained and tested. To harden the camera, the procedure described in ARL-MR-510 was followed. The cantype crystal in the camera was replaced with the Statek<sup>13</sup> surface mount crystal (part I.D. 4AT-4520-ASXI; description: CX4HGSM1-18.869-MHz crystal oscillator) which was available from parts from work done by John Condon (see figure 17).

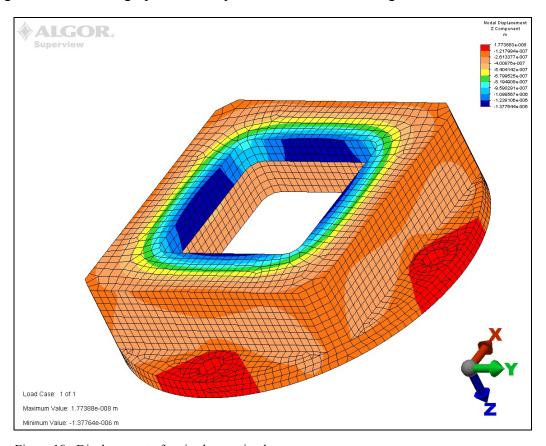
As with the previous test, the power and video connector was replaced with wires directly soldered to the circuit board. The CCD was sealed to the lens housing with Dow Corning RTV and the camera was encapsulated with STYCAST 1090SI with an LV23 catalyst. To allow for the installation of the PC72XS camera in the imager round, the camera mounting plate and mounting box designs were modified to fit the new camera (see appendix A). The only change in the camera mounting plate was the shape of the pocket, which was assumed to have a negligible effect on the stress in the plate under load. The mounting box (mounting box rev1) was redesigned to better distribute the clamping force on the camera (see appendix A). Several analyses of the revised mounting box were conducted to ensure that the displacement of the mounting box is smaller than the original version. Figure 18 shows the nodal displacement in the axial direction of the revised mounting box under the same loading conditions in figure 16. The maximum displacement in the axial direction of the revised part is approximately half the displacement of the original.

Figure 18. Displacement of revised mounting box.

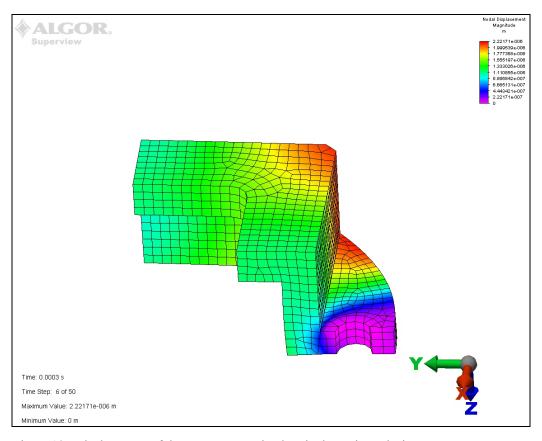
The dynamic analysis predicts that the maximum displacement of the mounting box is 2.22 x 10<sup>-6</sup>m. Figure 19 shows the graph of the displacement of the mounting box.

Figure 19. Displacement of the camera mounting box in dynamic analysis.
